# Manhole Inspection Summary

Manhole # S29II1026MH

Insp Date: **7/28/08 11:31 AM**

**Location** Address: **641 UNIVERSITY PKWY**

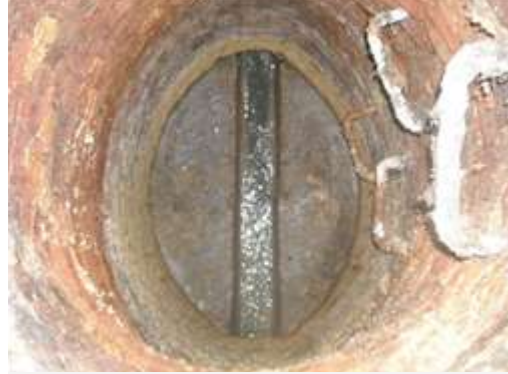
Top View

☐ Parged ☒ **Debris** (not Condition related)

Count: **4** Missing: **0** ☒ **Corroded**

☒ **Evidence Of Surcharge** Depth: **6** (ft.) ☐ Active Surcharge Present

Corroded steps. Evidence of surcharge - Bench debris.

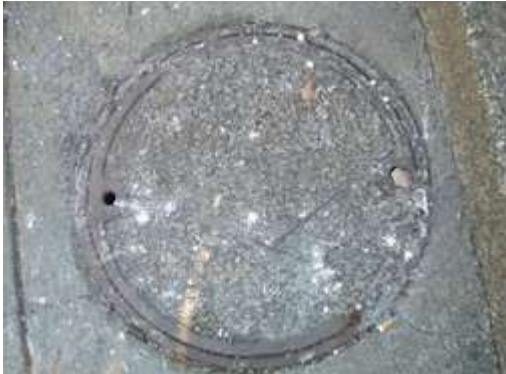
Defect

CEMENTED

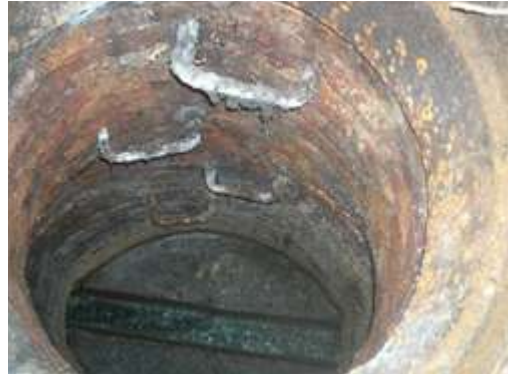
Defect

Condition: ☐ Sound ☐ Cracked ☐ Root Intrusion ☐ Loose Brick ☒ **Deteriorated**

Infiltration: ☐ None ☒ **Joint** ☐ Cracks ☐ Mortar ☐ Roots ☐ Wall

Infiltration: ☐ None ☐ Joint ☐ Cracks ☐ Mortar ☐ Roots ☒ **Wall**

Corbel deterioration and infiltration. Barrel infiltration.

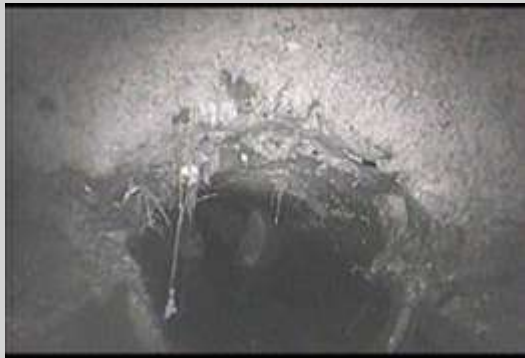
### 8 in. Circular Gravity Sewer Pipe Out @ 12 O'Clock

Deposits: ☐ None ☐ Mud ☐ Sludge ☐ Debris ☒ Grease

Silt Depth: **0** (in.) Deposits Extent: **Light**

Infiltration: **Evidence** Pipe Seal Cond: **Roots**

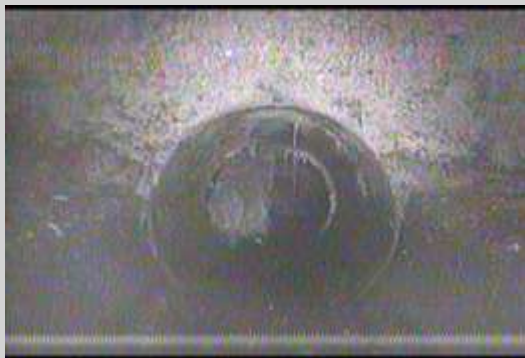
### 8 in. Circular Gravity Sewer Pipe In @ 6 O'Clock

Infiltration: **None** Pipe Seal Cond: **Unknown**
